Crack Growth Behavior in the Threshold Region for High Cyclic Loading

R. Forman, J. Figert and J. Beek

NASA JSC, Houston, TX 77058

Fatigue Crack Threshold Investigations at JSC

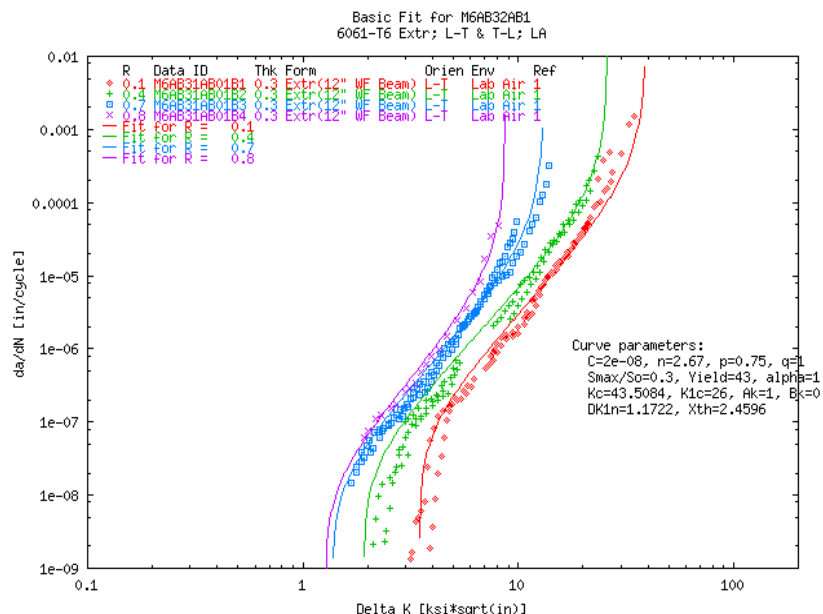
With Fanning Fit

NASGRO FITS: 6061-T6 AL Extr, L-T & T-L, LA

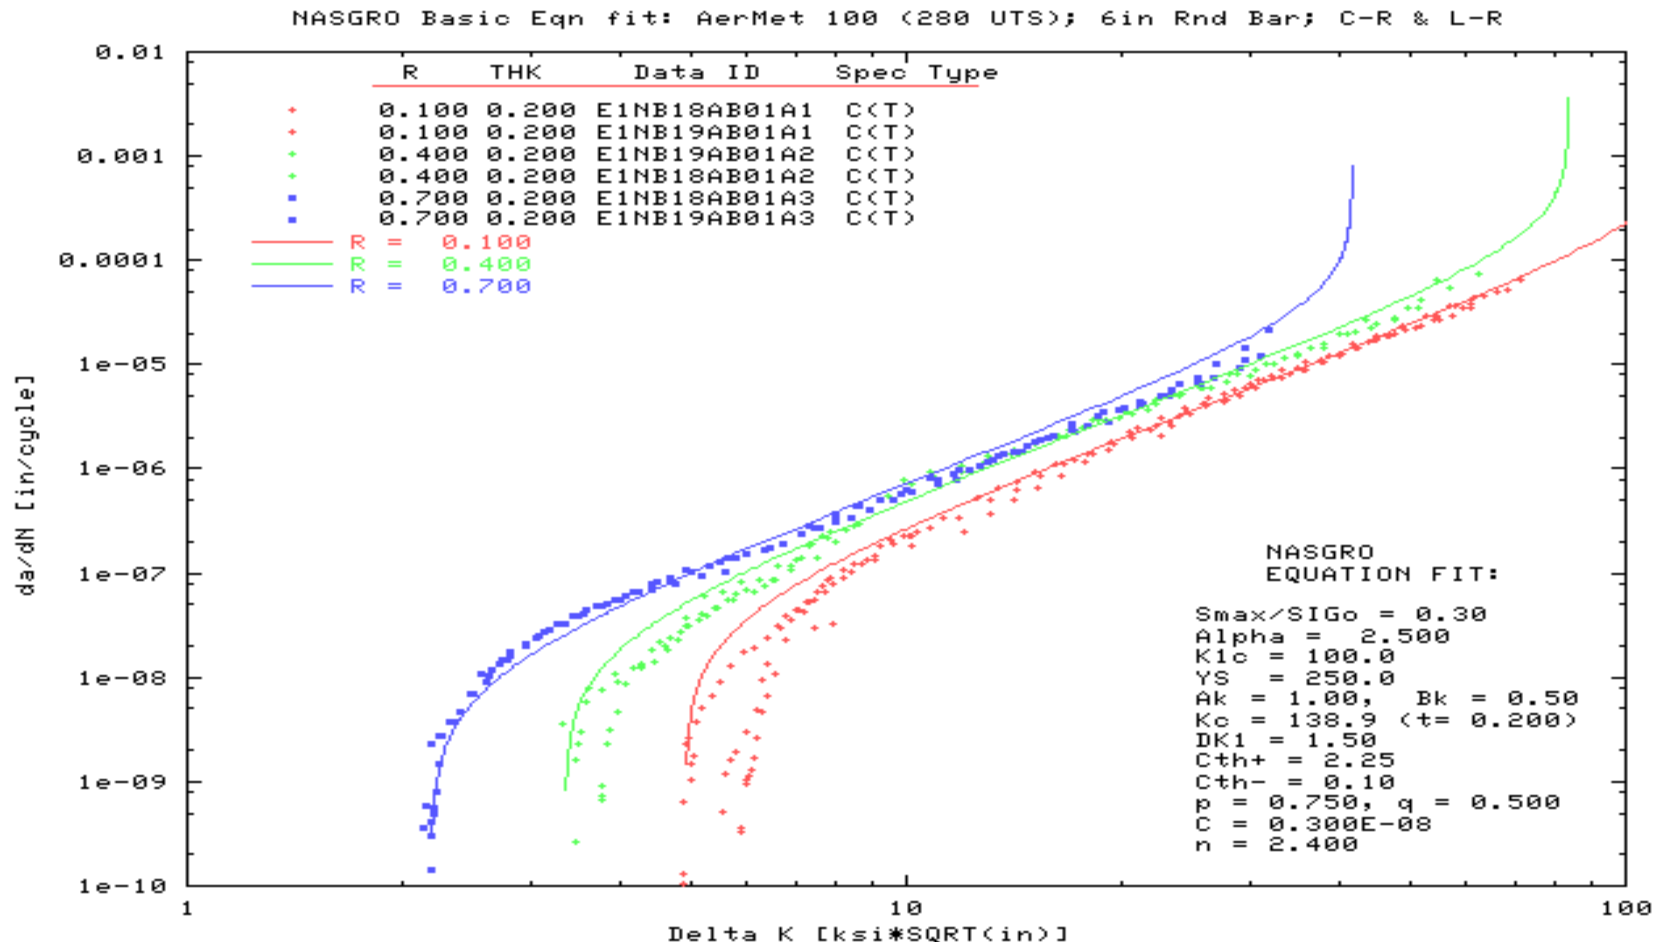
AerMet 100 Lab Air Data Fit – Cth = 2.25

Example of Significant Fanning that Occurred in Lab Air Testing

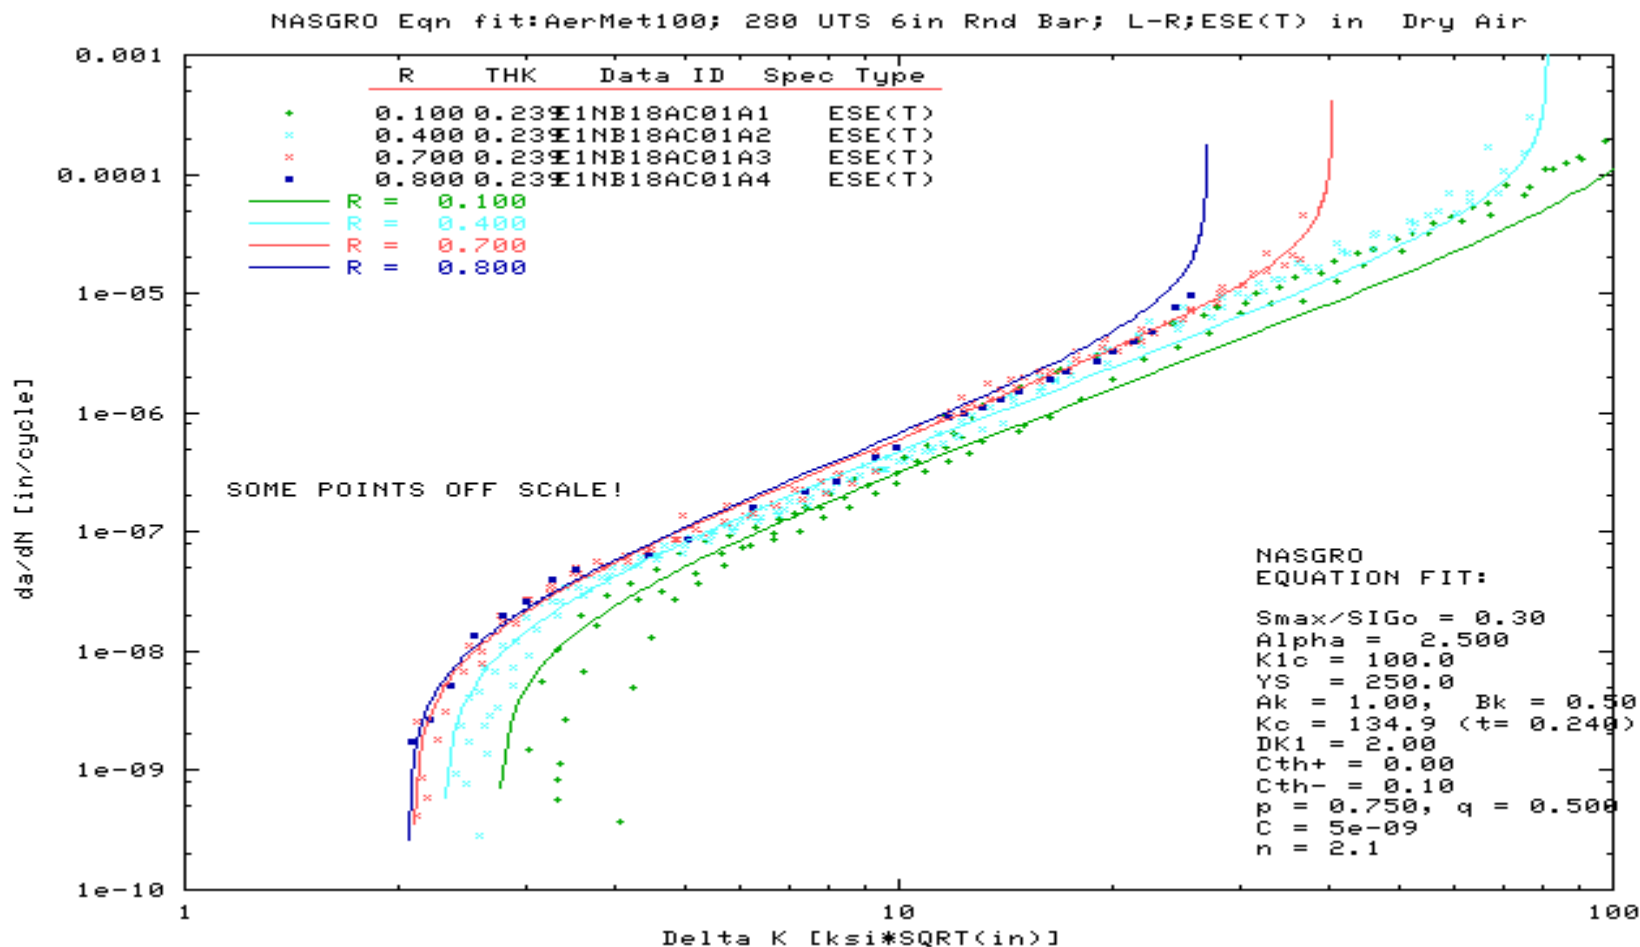
AerMet 100 Dry Air Data Fit – Cth = 0

Example of Decreased Fanning in Dry Air Testing

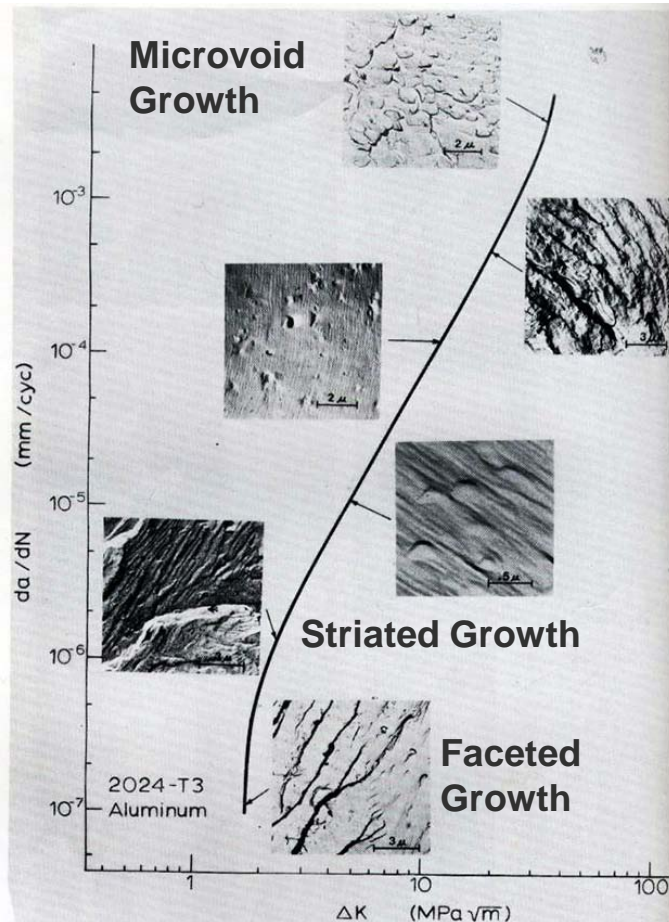
2024-T3 Aluminum

Hertzberg 1976: Micromorphology in the Ultra-Low Growth Rate Regime

FIG. 2—Electron fractographs showing fatigue fracture surface micromorphology at various points on the da/dN versus ΔK plot for 2024-T3 aluminum alloy.

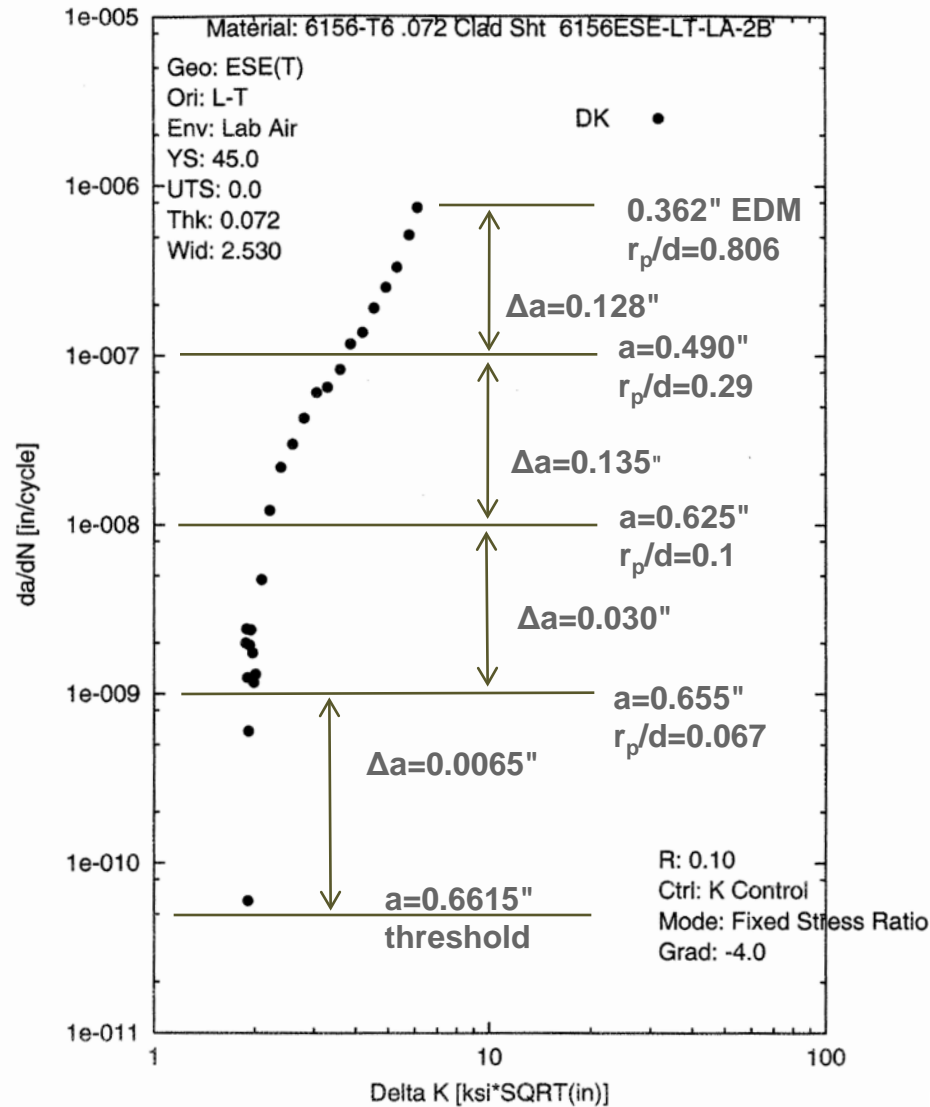
Load Shedding Test of 6156-T6 ESE(T) Specimen

For plane strain:

$$r_p = \frac{1}{6\pi} \left(\frac{K_{\max}}{YS} \right)^2$$

Grain diameter,
 $d = 1.5 \times 10^{-3}$

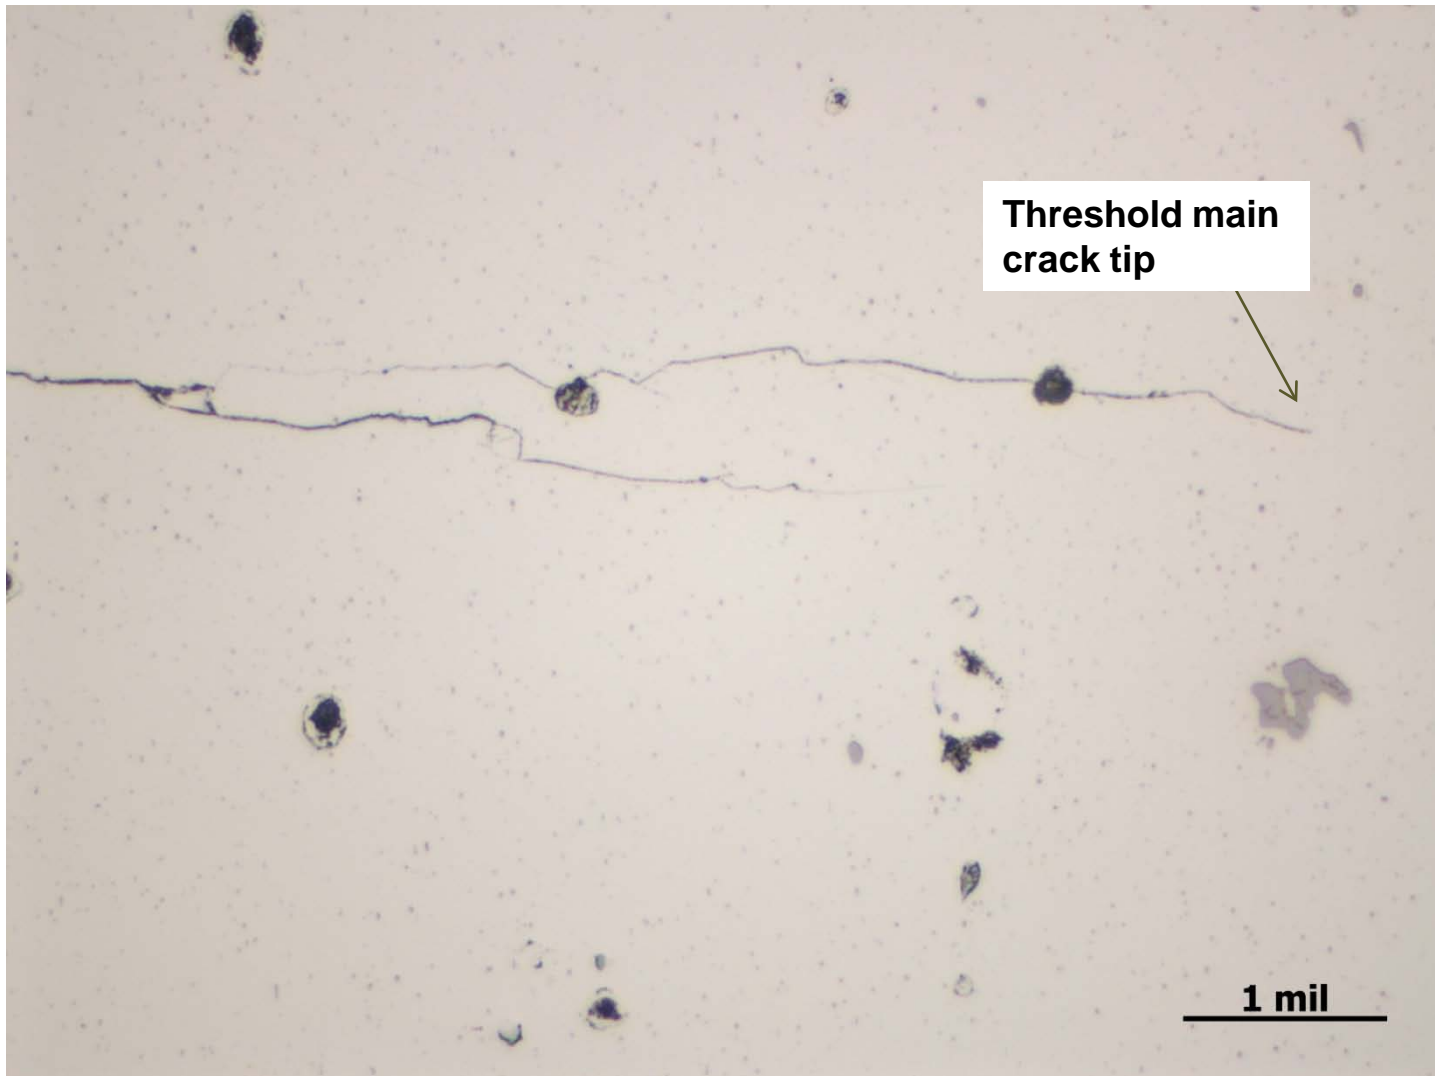
AI 6156-T6, R=0.1: Threshold Main Crack Tip

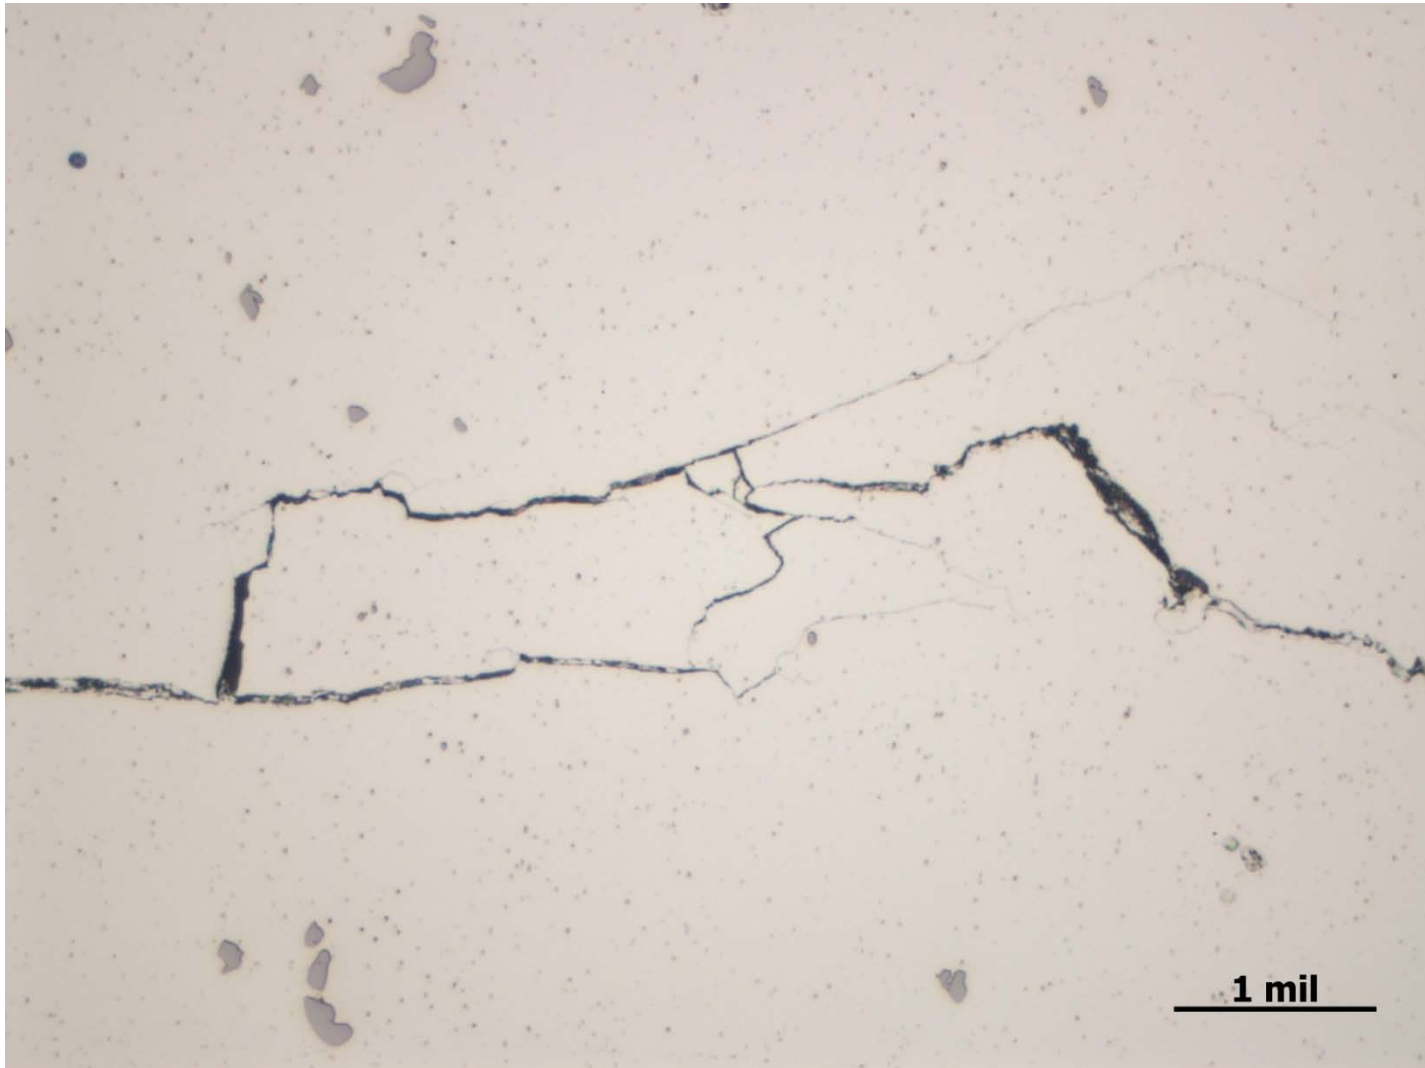
Al 6156-T6, R = 0.1: Close to Threshold Tip

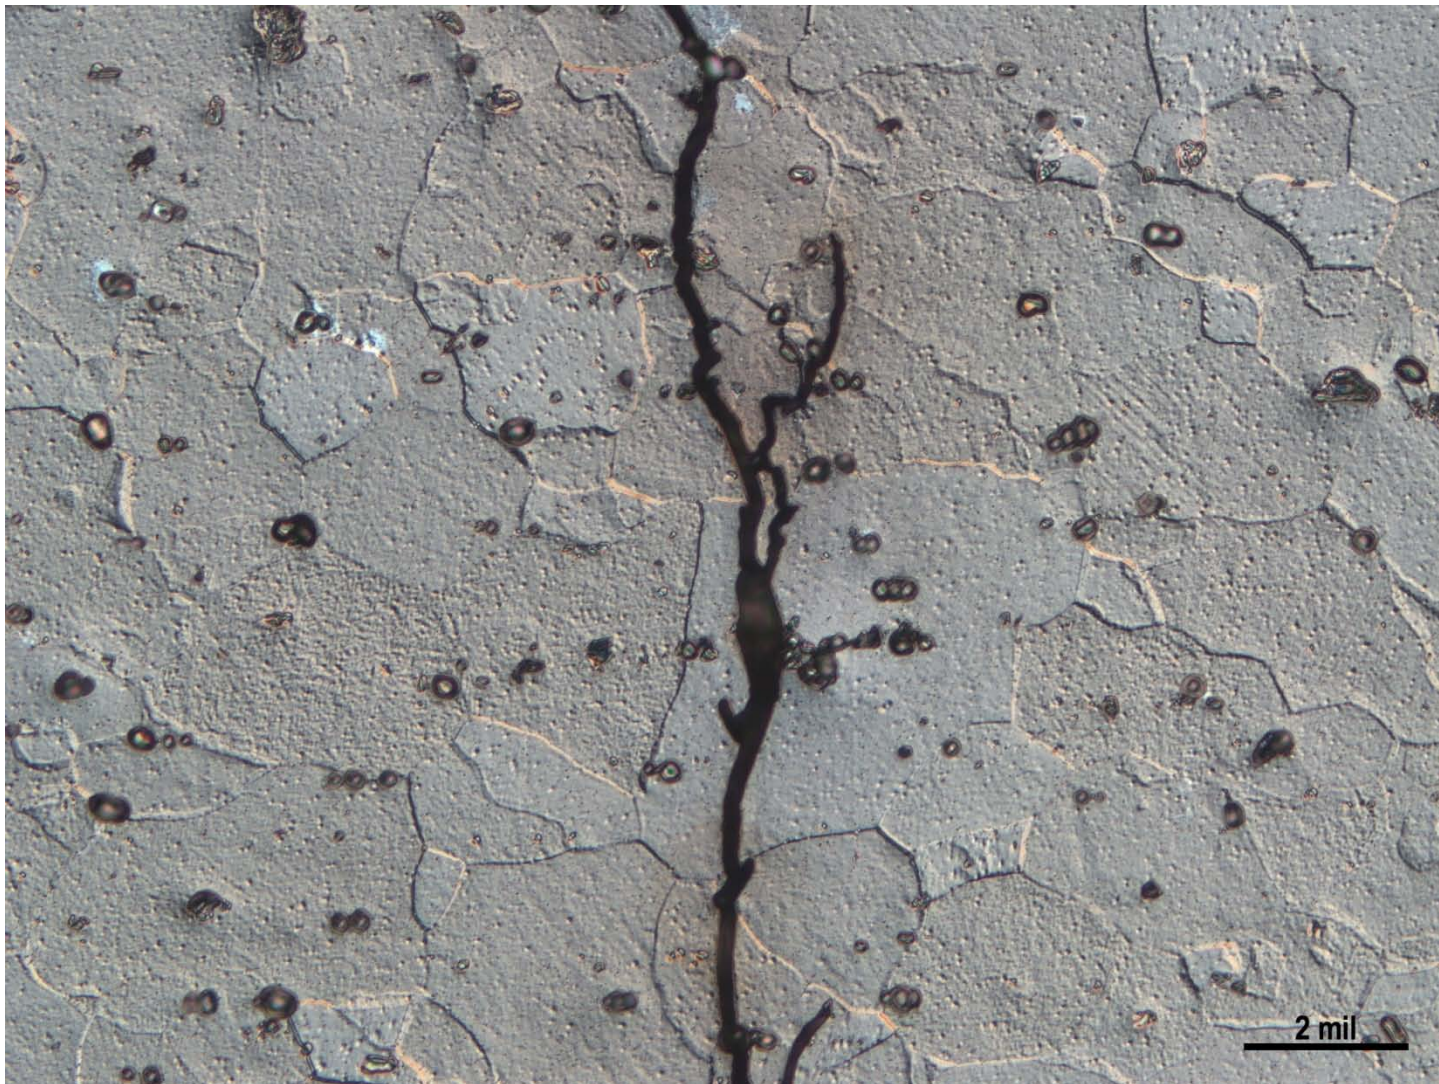
AI 6156-T6: Load Shedding Crack (etched to show grains)

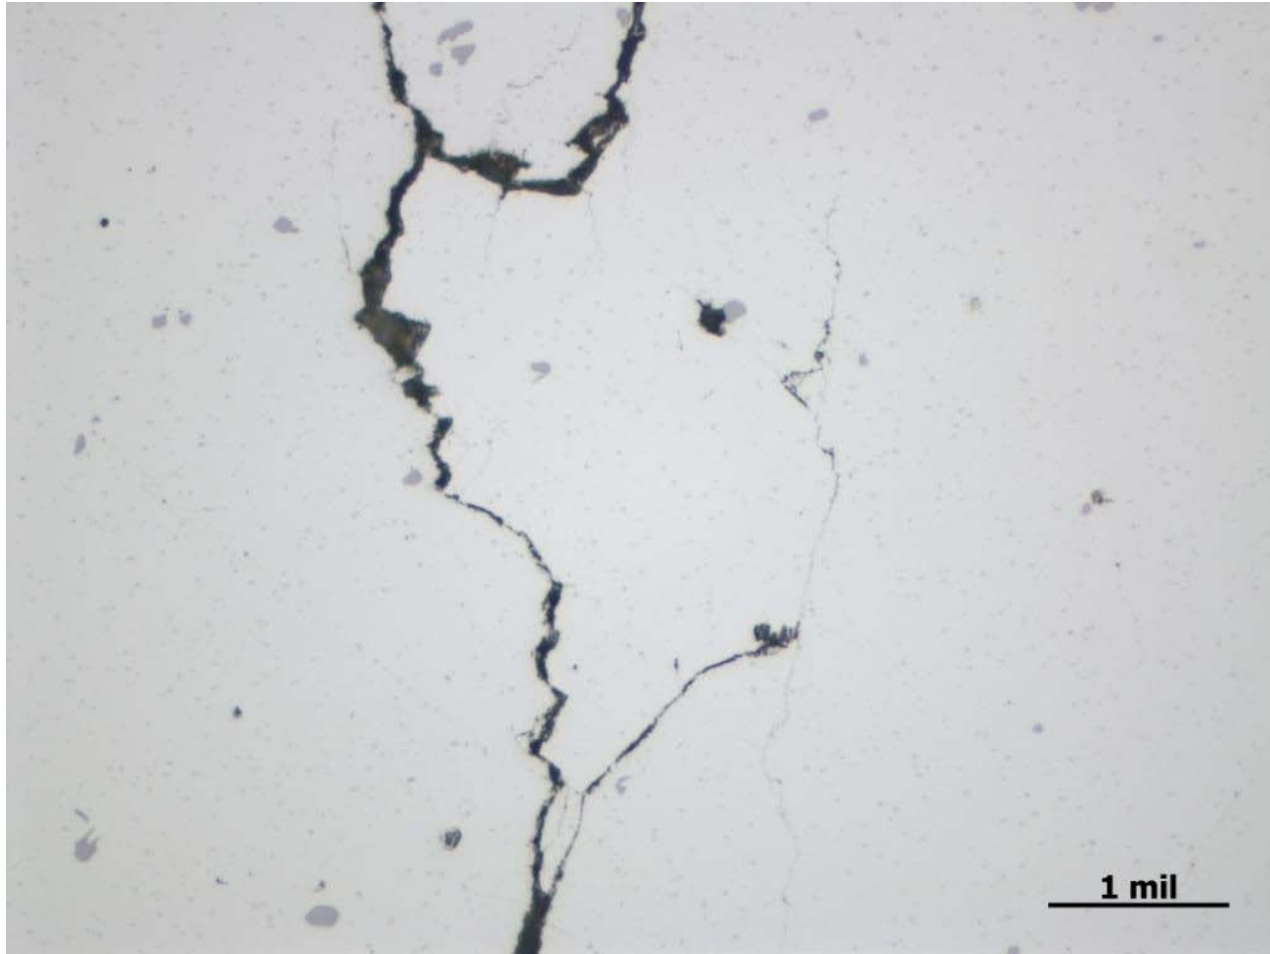
Al 6156-T6 Specimen, R = 0.7: Midway to Threshold Tip

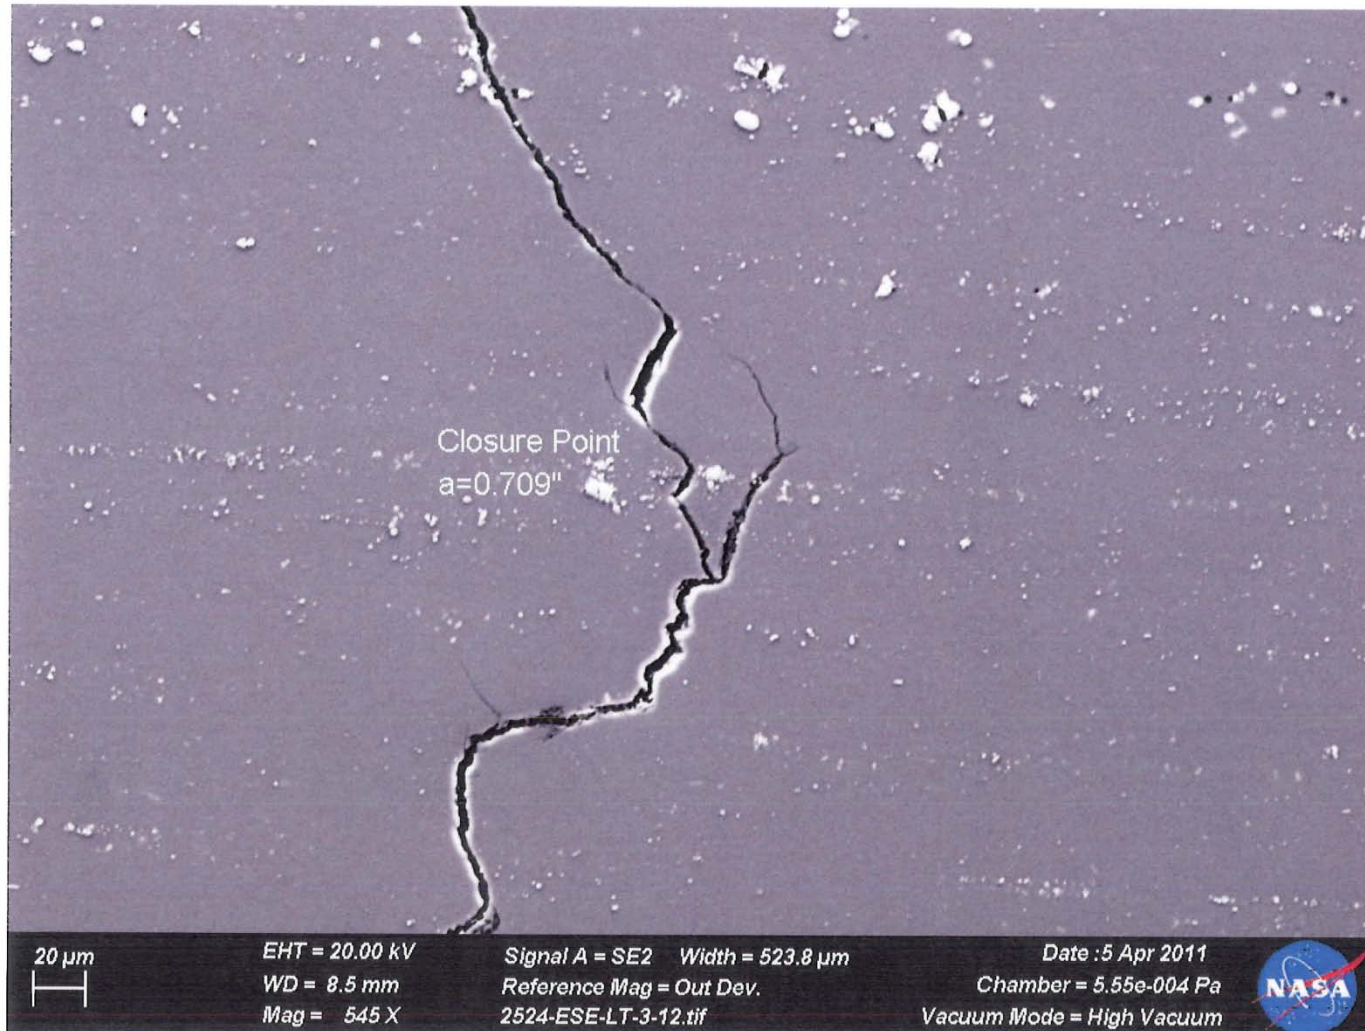
Fatigue Crack Sample: 2524 ESE-LT-3

AI 2524-T3 Specimen Showing a Crack Closure Point

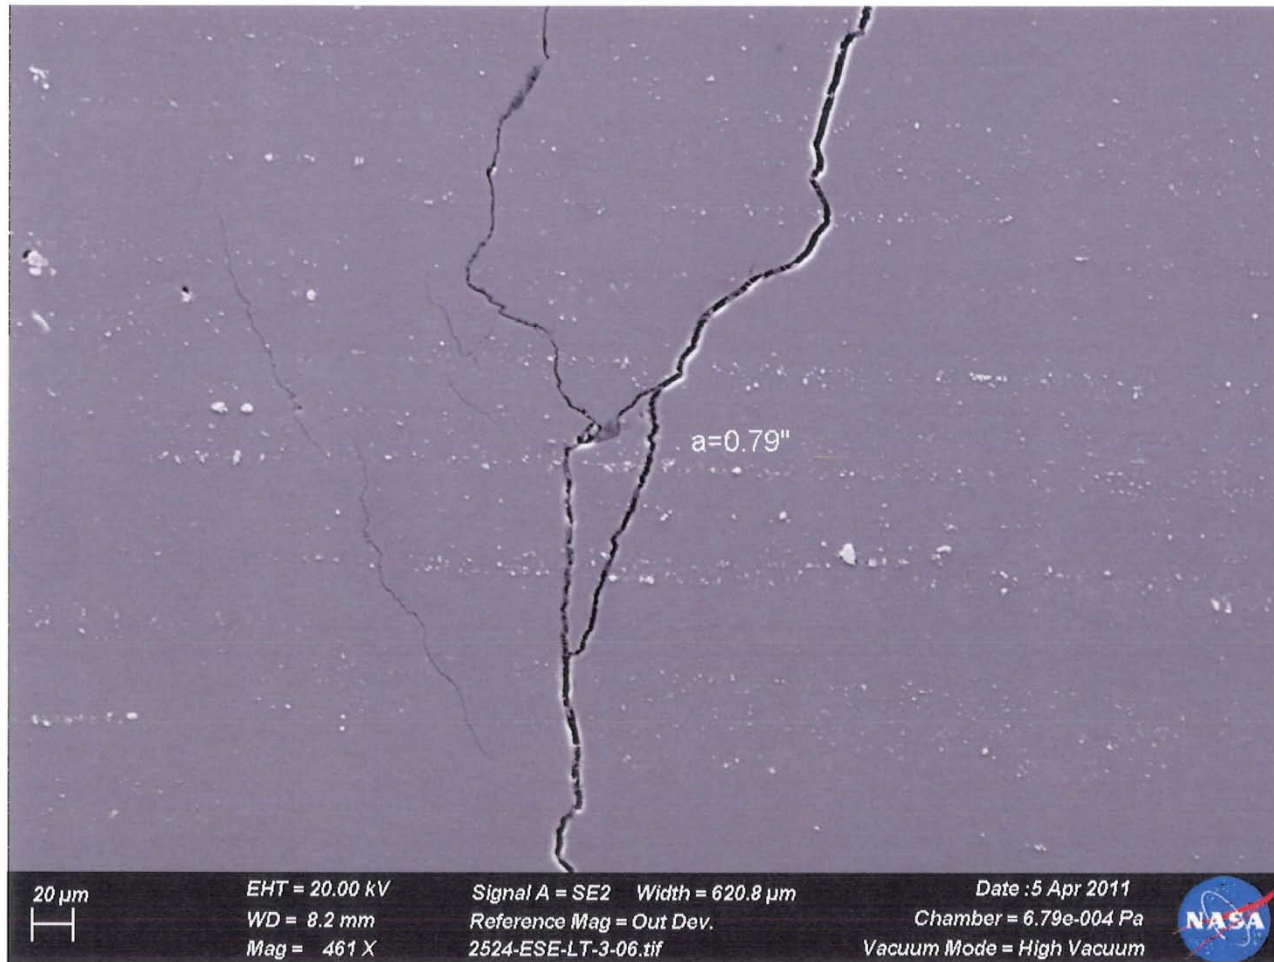
Fatigue Crack Sample: 2524 ESE-LT-3

Al 2524-T3 Specimen: Midway in Load Shedding Phase

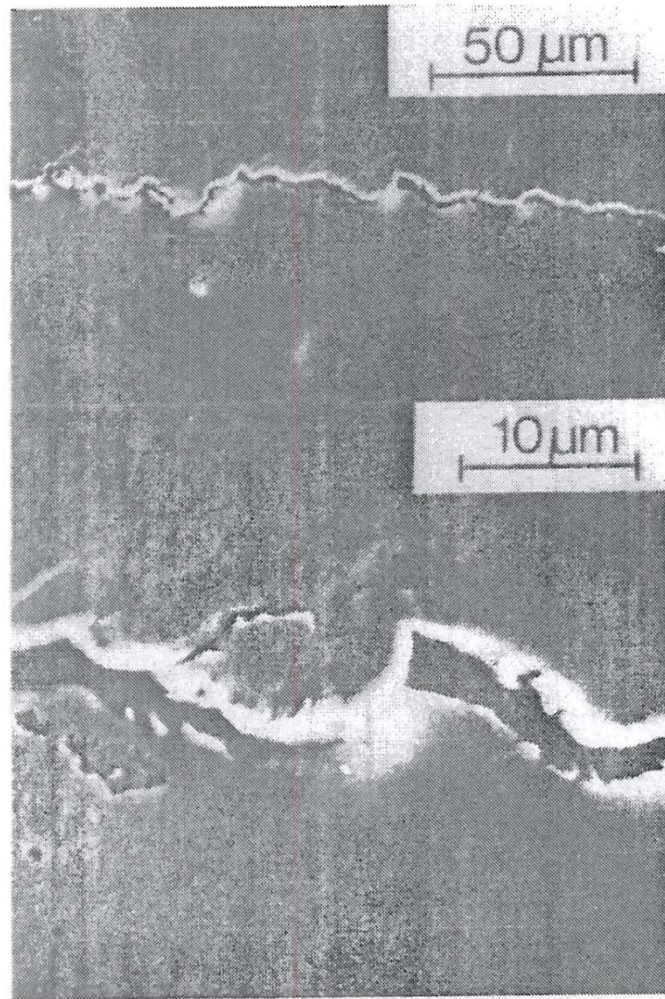
IMI 685 Ti Specimen Showing a Crack Closure Point

MA Hicks, Fatigue of Engineering Materials, & Structures
Vol. 6, No. 1, pg 59
